NAFEC TECHNICAL LETTER REPORT

NA- 80-17-LR

PRELIMINARY EVALUATION OF THE
PERFORMANCE OF ADVANCED AND
CONVENTIONAL AIRCRAFT WINDOWS
IN A MODEL FIRE ENVIRONMENT

FEDERAL AVIATION ADMINISTRATION
NATIONAL AVIATION FACILITIES EXPERIMENTAL CENTER
Atlantic City, New Jersey 08405

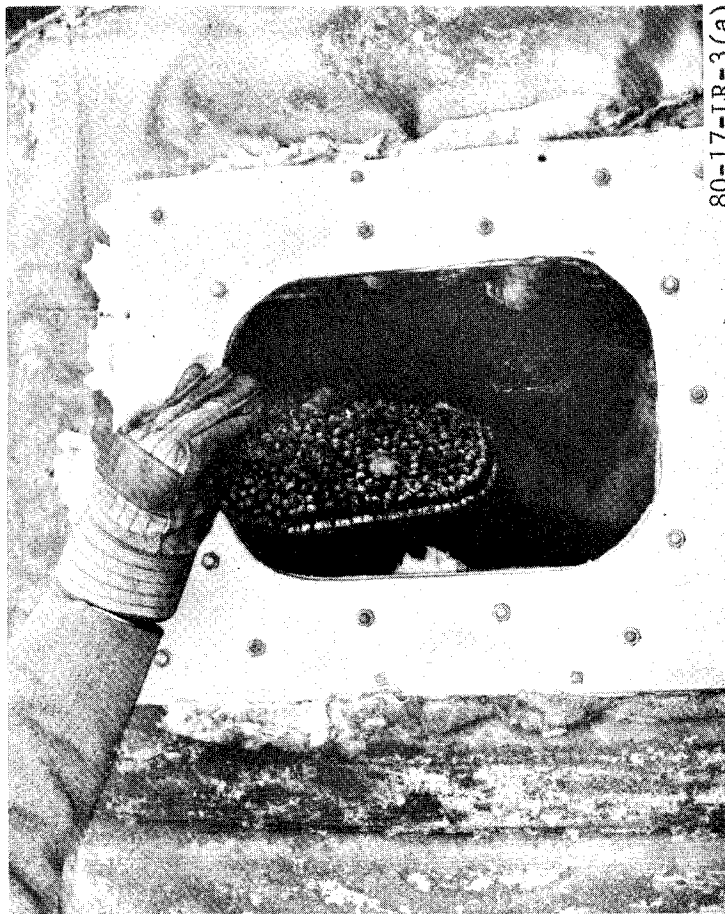
TEST 1

Figure 3 shows the condition of the two full size windows after extinguishment of the fires in tests 1 and 2, respectively. NAFEC firemen started extinguishment when an observer noted burnthrough 108 seconds after the start of test 1 and 240 seconds after the start of test 2. Tests 3 and 4 were run for 113 seconds and 115 seconds, respectively, before extinguishment of the pool fire was started. The tests were halted when an observer could see the fire breaking through either of the window sections. Figure 3 also shows the window conditions for tests 3 and 4, respectively. The photographs show that the stretched acrylic windows failed by means of shrinking. The epoxy/polycarbonate window failed only in test 2 which was run for a considerable length of time. When the epoxy/polycarbonate window was exposed to fire, the outer ply formed a char which apparently served as an effective heat-blocking device.

Noticeable speckling of the stretched acrylic window appeared at 28 seconds into the test. At 52 seconds the window darkened considerably, and at 104 seconds, the first breakthrough of the external fire was noted.

The glass transition temperature (T_g) of acrylic will usually be around 230°F , while that of polycarbonate is around 300°F . When the backface temperature on either material approaches T_g , failure results.

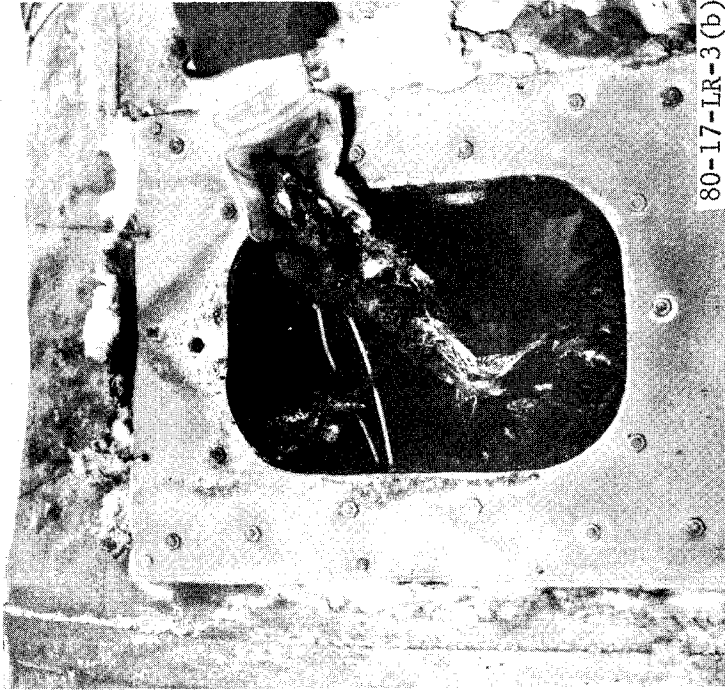
TEST 2

The epoxy/polycarbonate window first showed speckling at 30 seconds and darkened at 70 seconds. By 90 seconds the window was very dark and evidenced some stress cracks in the epoxy layer. From 90 to 190 seconds (when the camera stopped), the window was opaque and showed no signs of failure. Observations from the end of the fuselage indicate that the window failed at approximately 240 seconds. It should be noted that tests 1 and 2 were both run at 7 to 10 knots windspeed. Tests 3 and 4, however, were run at 12 and 3 knots, respectively. In both tests 3 and 4, the lower calorimeter on the window mount read 13 British thermal unit per square foot second ($\text{Btu}/\text{ft}^2\text{-sec}$), while the upper calorimeter read 16 and 15 $\text{Btu}/\text{ft}^2\text{sec}$, respectively.

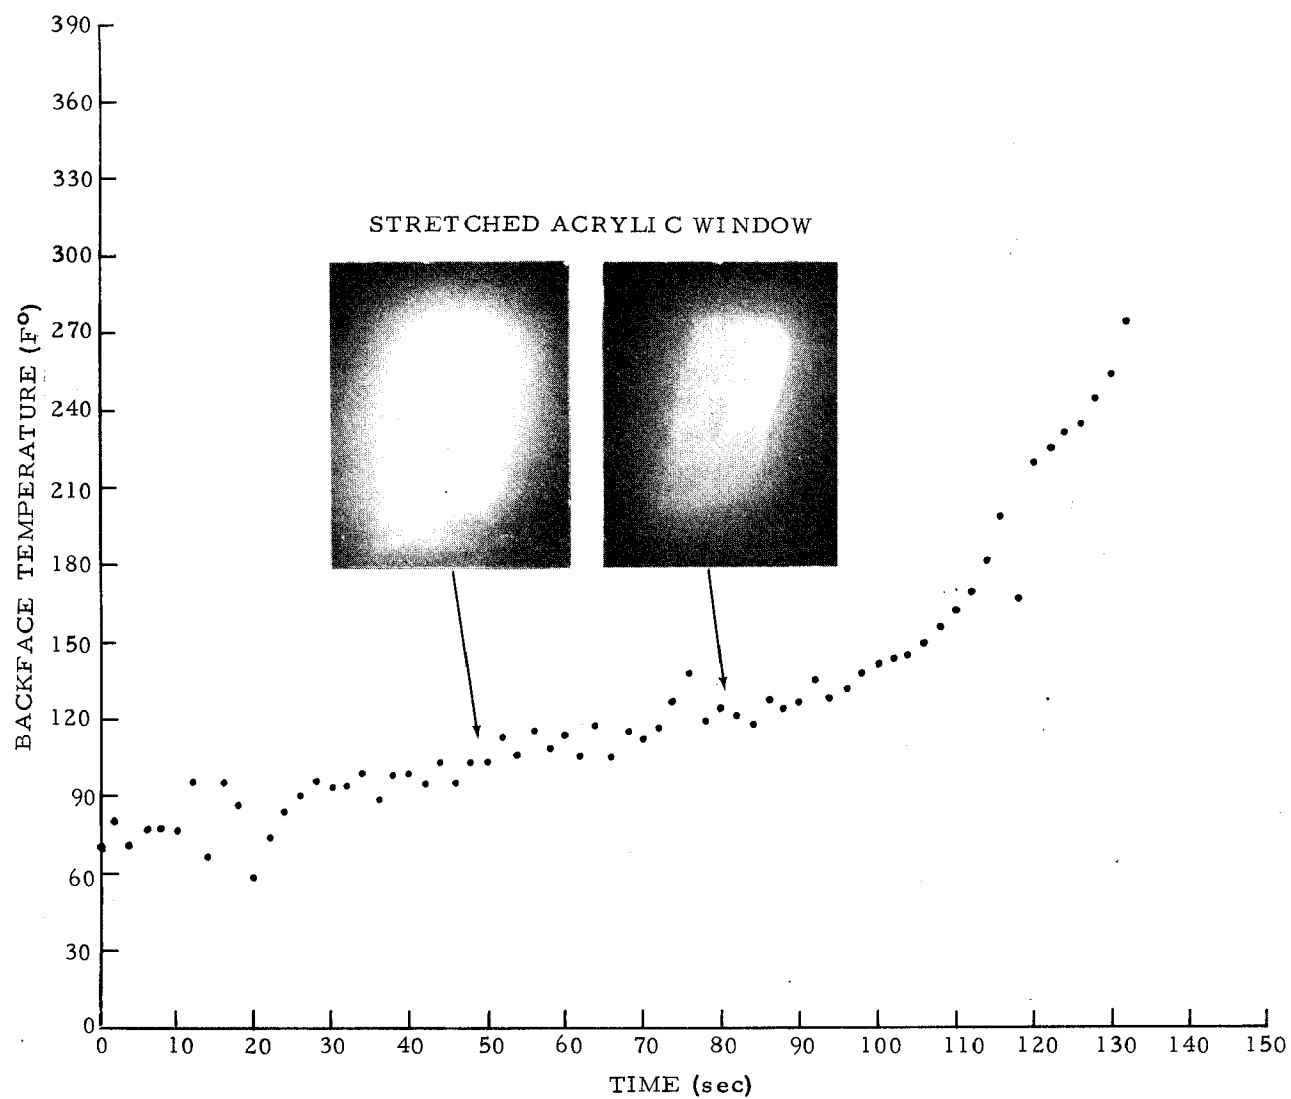
FIGURE 4. BACKFACE TEMPERATURE--(TEST 1)

Figures 4 and 5 shows backface temperature rises for test 1 and 2 along with corresponding photographs taken by the motorized still camera. The behavior of the windows during the fire can thereby be observed. The photographs shown in figure 4 are selected from sets of 35-mm color stills which were sequenced every 2 seconds during the test. The motorized still camera inside the fuselage viewed the fire through the window.

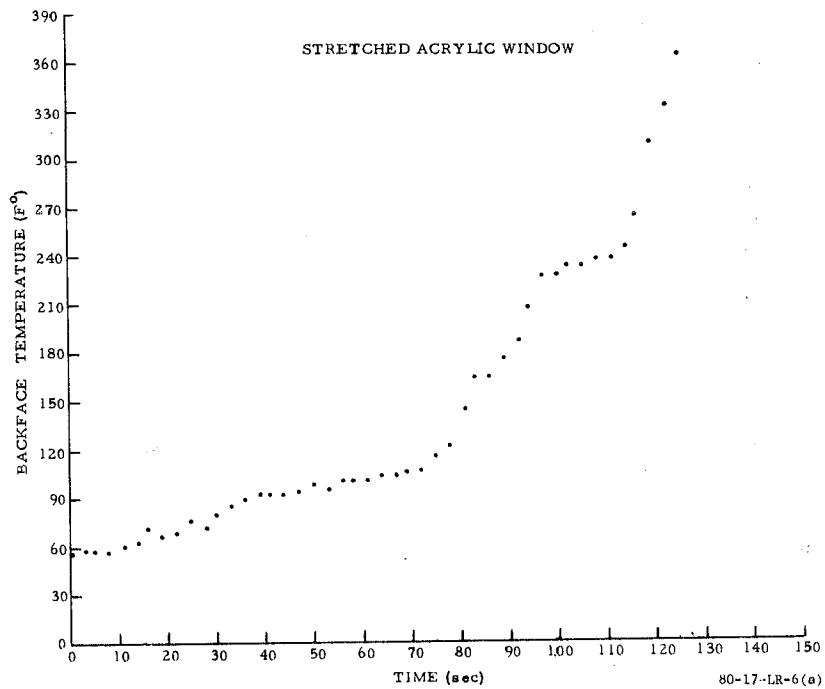
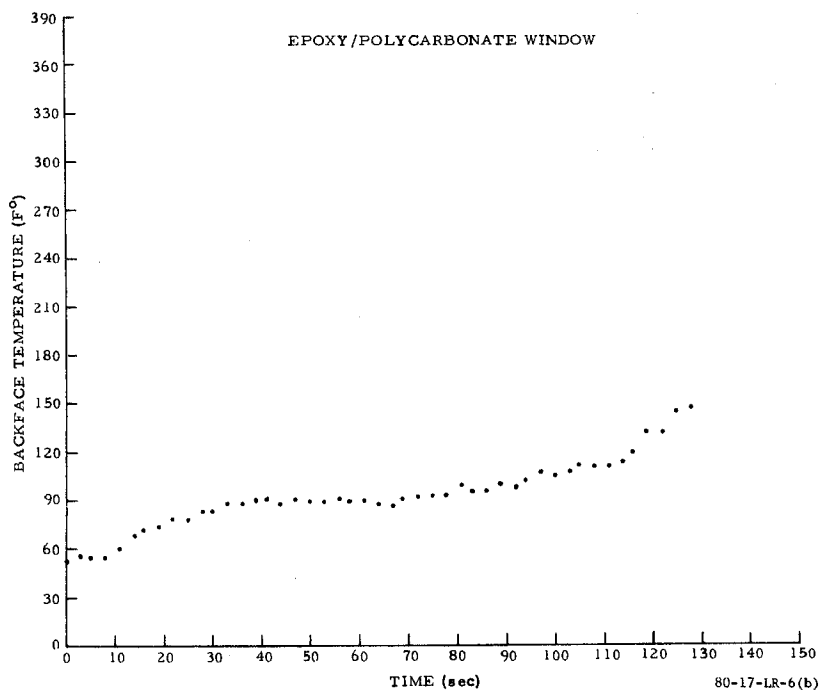
FIGURE 6. BACKFACE TEMPERATURE--(TEST 3)

The backface temperature-rise curves for tests 3 and 4 are shown in figures 6 and 7. For the first 40 to 60 seconds, the backface temperatures of both windows in a given test are equivalent. At this time, the backface temperature of the conventional window becomes higher.
